# Manhole Inspection Summary

Manhole # S49AA\_048MH

Insp Date: **5/8/08 9:13 AM**

**Location** Address: **rear 535 n glover st**

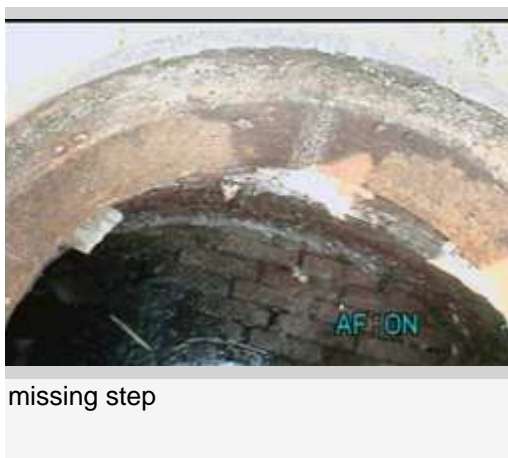
Defect 3

**Steps** Count: **1** Missing: **1** ☒ **Corroded**

missing step

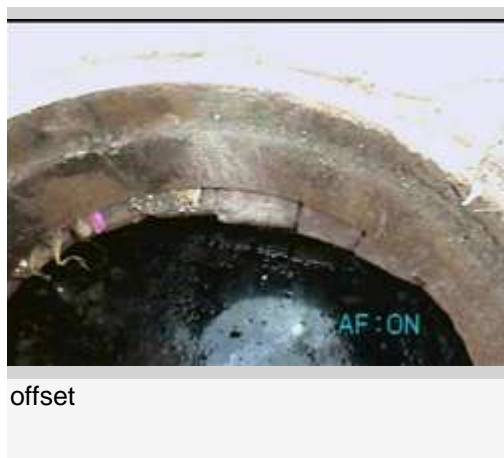
Defect 2

**Frame** Offset: **1** (in.) Condition: ☒ Sound ☐ Cracked ☐ Leaks

offset

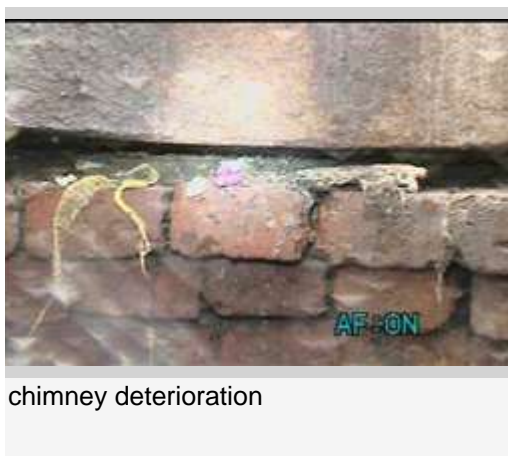
Defect 1

Condition: ☐ Sound ☐ Cracked ☐ Root Intrusion ☐ Loose Brick ☒ **Deteriorated**

chimney deterioration
